## Areas of Interest Along the Main Study Corridor

WAWAYANDA CREEK PRIMARY CORRIDOR - AREAS OF INTEREST  
VILLAGE OF WARWICK, NEW YORK

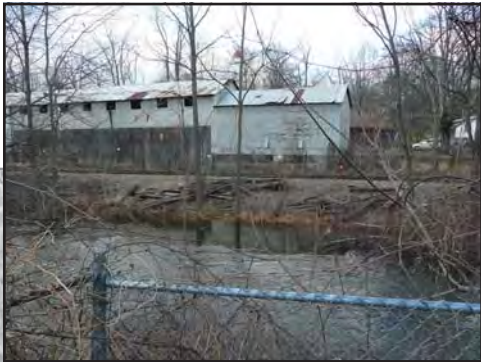
UNSIGHTLY RAILROAD R.O.W. DEBRIS  
AND UNDER UTILIZED STRUCTURES

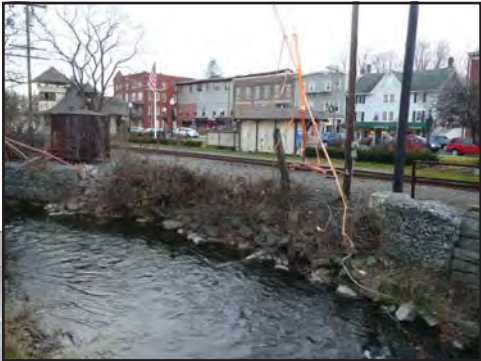
DEGRADED BANKS OF CREEK ADJACENT TO  
ATTRACTIVE VILLAGE SHOPS AND OPEN SPACES

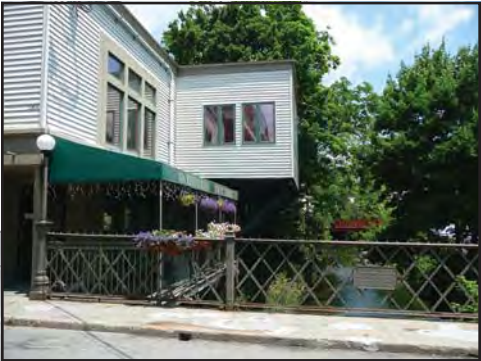
HISTORIC STRUCTURES STILL INTACT SUCH AS  
BANK STREET BRIDGE

The only remaining historic bridge in the Village is located on Bank Street and it creates an important visual rhythm with the pedestrian bridge that repeats the design. Lighting on the bridge is authentic and also repeated in the pedestrian bridge. It is extremely important to retain the character of this bridge through restoration rather than removal. A Wawayanda Creek advocacy group in conjunction with the Warwick Historical Society could help protect historic resources within the Village Creek corridor and investigate funding for restoration as opposed to removal.

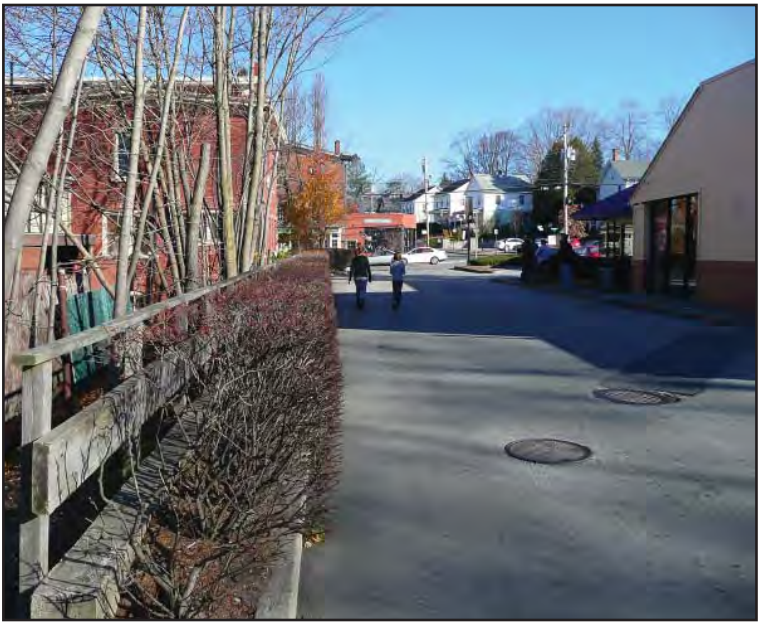
*Creekside Pedestrian Walk Needed for Safe Access from Mitchel Mall to Oakland Ave.*

Creating a new sidewalk from Oakland Avenue to the Mitchel Mall on the north edge of the Burger King entry drive and parking area would make important pedestrian connections as well as better integrate this area into the main business district of the Village. The Creek corridor would become more visible and appreciated if fencing and lighting at the Burger King parking lot were replaced and upgraded to the Village style as recommended for the Mitchel Mall, and if a sidewalk running parallel to the Creek Corridor were installed. The generous entry drive that is partially one-way would render this possible. Walking along the southern façade of the historic Warwick Valley Dispatch building would add interest to the route. From the Mitchel Mall parking area to Elm Street bridge a less formal walkway may be needed because of the grassed area that is already walkable, provided that the dumpsters are moved across the parking area to provide unimpeded access.

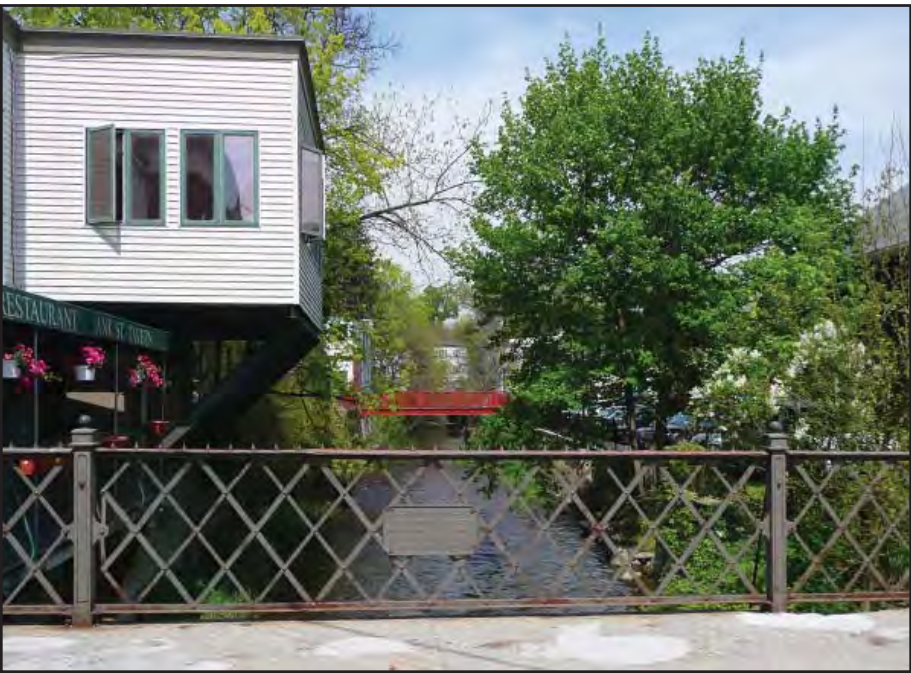
*Bank Street Bridge an Historic and Visual Asset*
